NUMBER: 23-017-18

Headlamp Condensation and Fogging

This bulletin involves installing updated vent caps on the headlamp assembly.

2011 - 2017	(LD)	Dodge Charger
2015 - 2017	(LA)	Dodge Challenger
2011 - 2017	(LX)	Chrysler 300

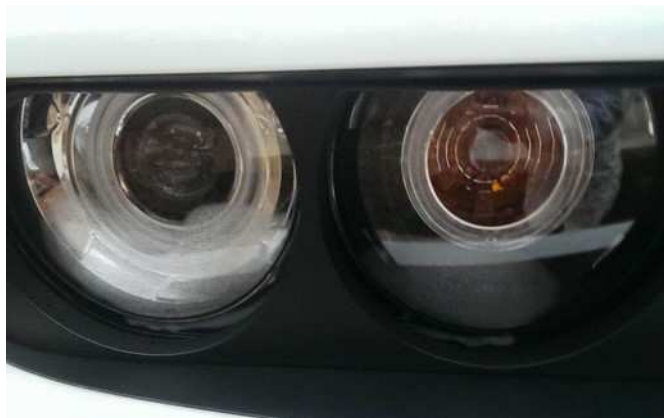
Fig. 1

Normal Headlamp Clearing - Install Updated Vent Caps

2. Did **both** headlamp lenses start to clear (Fig. 1) ?
 - YES>>> Replace the vent caps. Proceed to [Step 1](#) of the Repair Procedure.
 - NO>>> Proceed to [Step 3](#).
3. If one headlamp assembly cleared and the other still has heavy condensation in it, only install the vent caps on the assembly that cleared up. Proceed to [Step 1](#) of the Repair Procedure. **The headlamp that still has condensation with no clearing in it will need to be replaced. Use normal Service Information and normal warranty process and procedures.**

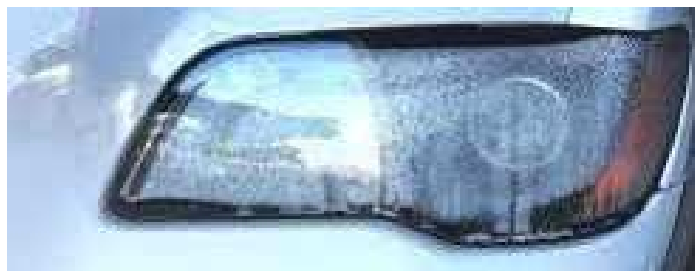
Fig. 2

Heavy Condensation With No Clearing - Replace Headlamp Assembly

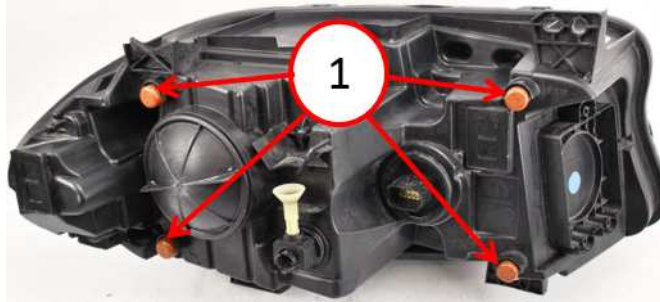
Fig. 3
Example Location Of Vent Caps - Charger

1 - Four Old Style Vent Caps

1. Remove the headlamp assembly. Refer to the detailed service procedures available in DealerCONNECT> TechCONNECT> 8L - Lamps and Lighting / Lamps/Lighting - Exterior / Unit, Front Lamp/Removal.
2. Remove and discard the old vent caps by pulling them rearward off the headlamp assembly (Fig. 3) .

3. Install the new (brown) vent caps by pushing them on the bosses of the headlamp assembly.
4. Install the headlamp assembly. Refer to the detailed service procedures available in DealerCONNECT> TechCONNECT>08 - Electrical/8L - Lamps and Lighting/Lamps/Lighting - Exterior/Unit, Front Lamp/Installation.
