NUMBER: 23-012-17 REV. A

Wheel Liner Push Pin Fastener Replacement

2015 - 2017 (LD)

Dodge Charger

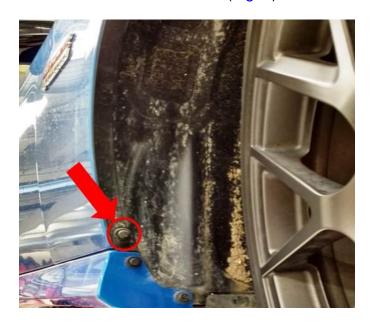
Fig. 1 Old Fastener

The customer may describe a rattle from the left, right or both, front wheel openings while driving. This condition is caused from one or both plastic front wheel liner fasteners loosening from their locations.

1. Turn the steering wheel to full stop one direction at a time and remove both the left and right push fasteners from each wheel liner (Fig. 1). Discard fasteners.

2. Using a hand plastic rivet tool, install two new rivets on the left and right wheel liners.
