Safety Recall R07 Fuel Rail Crossover Hose

2015 (LA) Dodge Challenger SRT

(LD) Dodge Charger SRT

The fuel rail crossover hose on about 110 of the above vehicles may leak fuel. The fuel rail crossover hose may have been damaged during the manufacturing process. The damage cannot be reliably detected and may cause a fuel leak without warning. A leaking engine fuel rail crossover hose, in the presence of an ignition source, could cause an underhood fire.

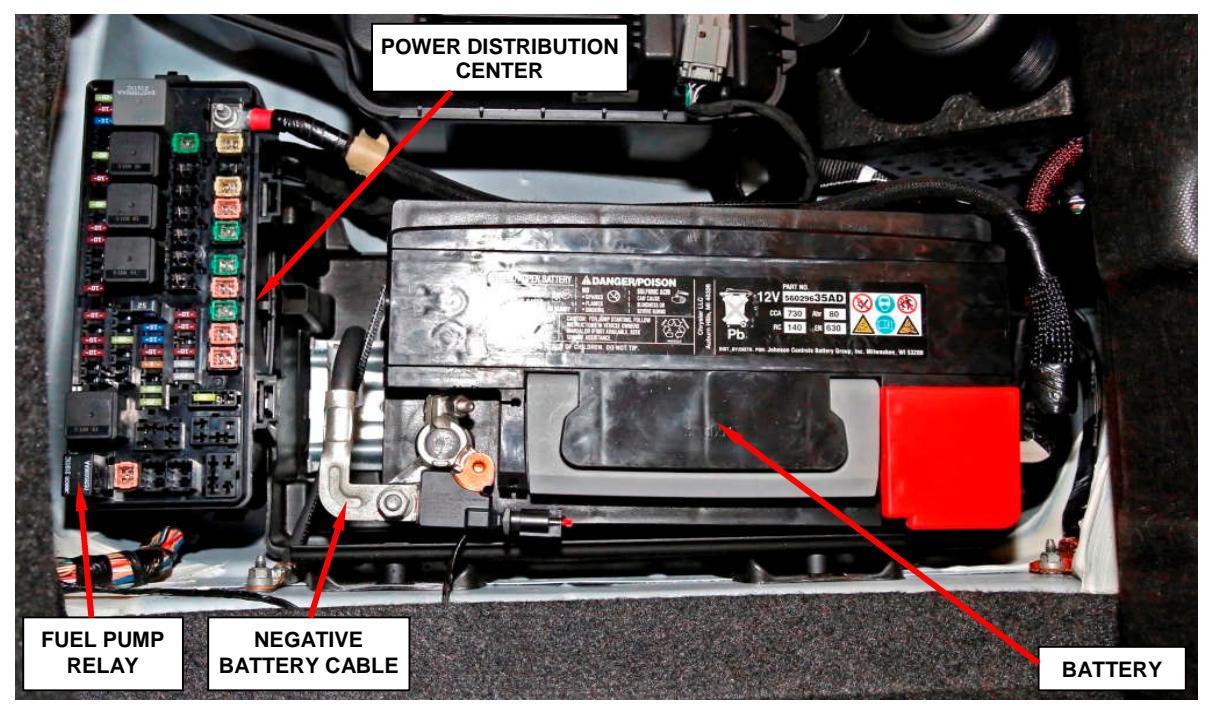
Figure 1 – Fuel Pump Relay Location

NOTE: The fuel pump relay is located in cavity number 72 of the PDC located next to the battery in the trunk (Figure 1).

- 1. Use the following procedure to release the fuel pressure from the fuel injection fuel rail:
 - a. Remove the fuel pump relay from the Power Distribution Center (PDC).

- b. With the fuel pump relay removed, start and run the engine until it stalls.
- c. Attempt restarting engine until it will no longer run.
- d. Turn the ignition to the "OFF" position.
- e. Install the fuel pump relay into cavity number 72 of the PDC (Figure 1).

- 2. Disconnect and isolate the negative battery cable (Figure 1).
- 3. Remove and save both engine fuel injector covers (Figure 2).
- 4. Using compressed air, blow air around each injector on the left fuel rail to remove any debris that may have collected around the fuel injectors, supercharger and/or intake manifold area (Figure 3).

- 21. Connect the fuel pressure sensor wire harness connector.
- 22. Install both engine fuel injector covers (Figure 2).
- 23. Connect the negative battery cable (Figure 1).
- 24. Start the engine and check for fuel leaks at the fuel injector rail and fittings.
- 25. Connect the wiTECH scan tool to the vehicle and clear all Diagnostic Trouble Codes (DTC's).
- 26. Remove the wiTECH and return the vehicle to the customer.

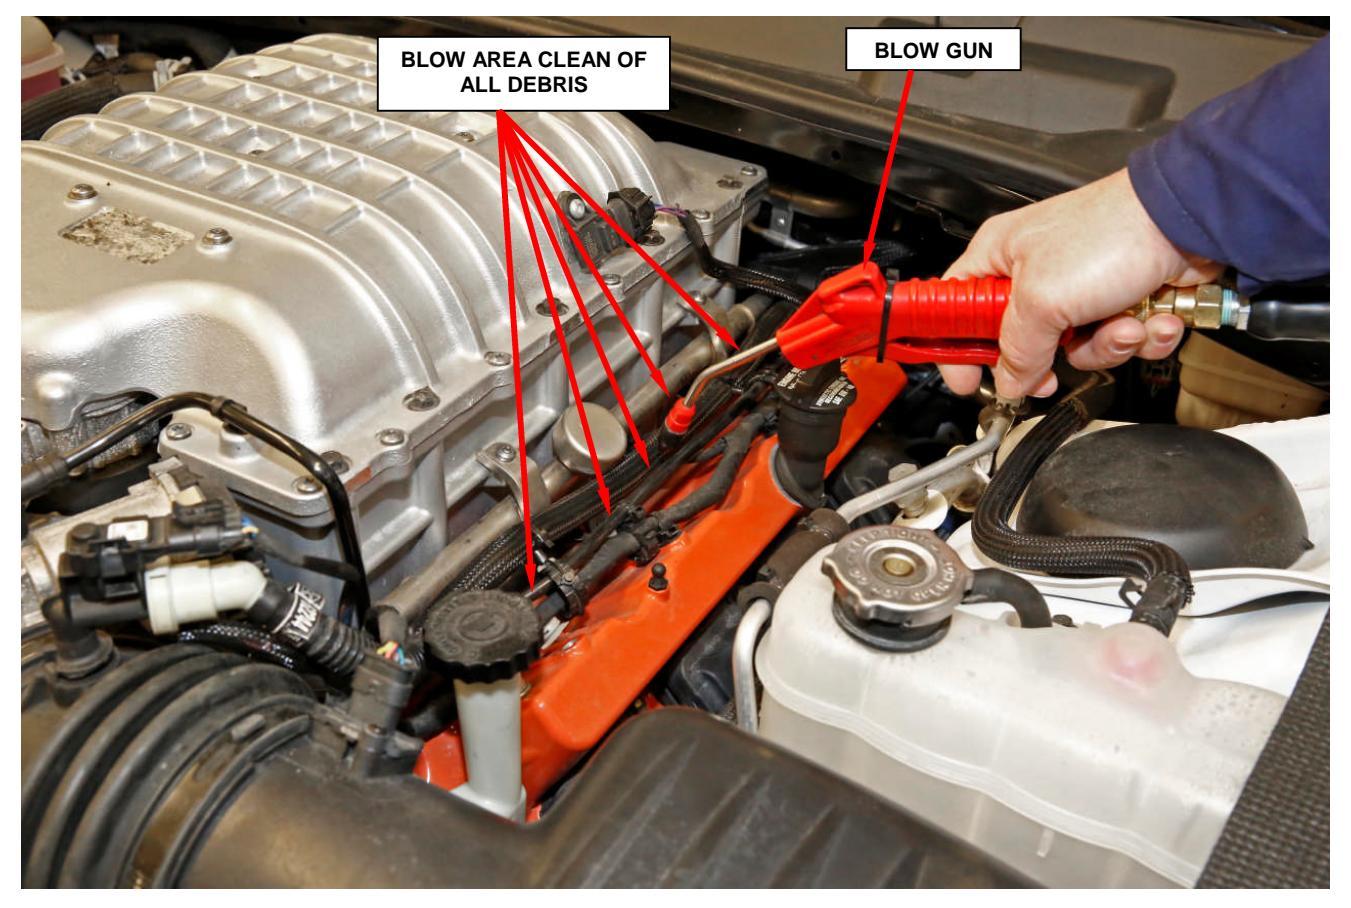
Figure 3 – Clean Injector Area with Compressed Air

CAUTION: Failure to clean the injector area with compressed air could allow debris to enter the engine when the fuel injectors are removed.

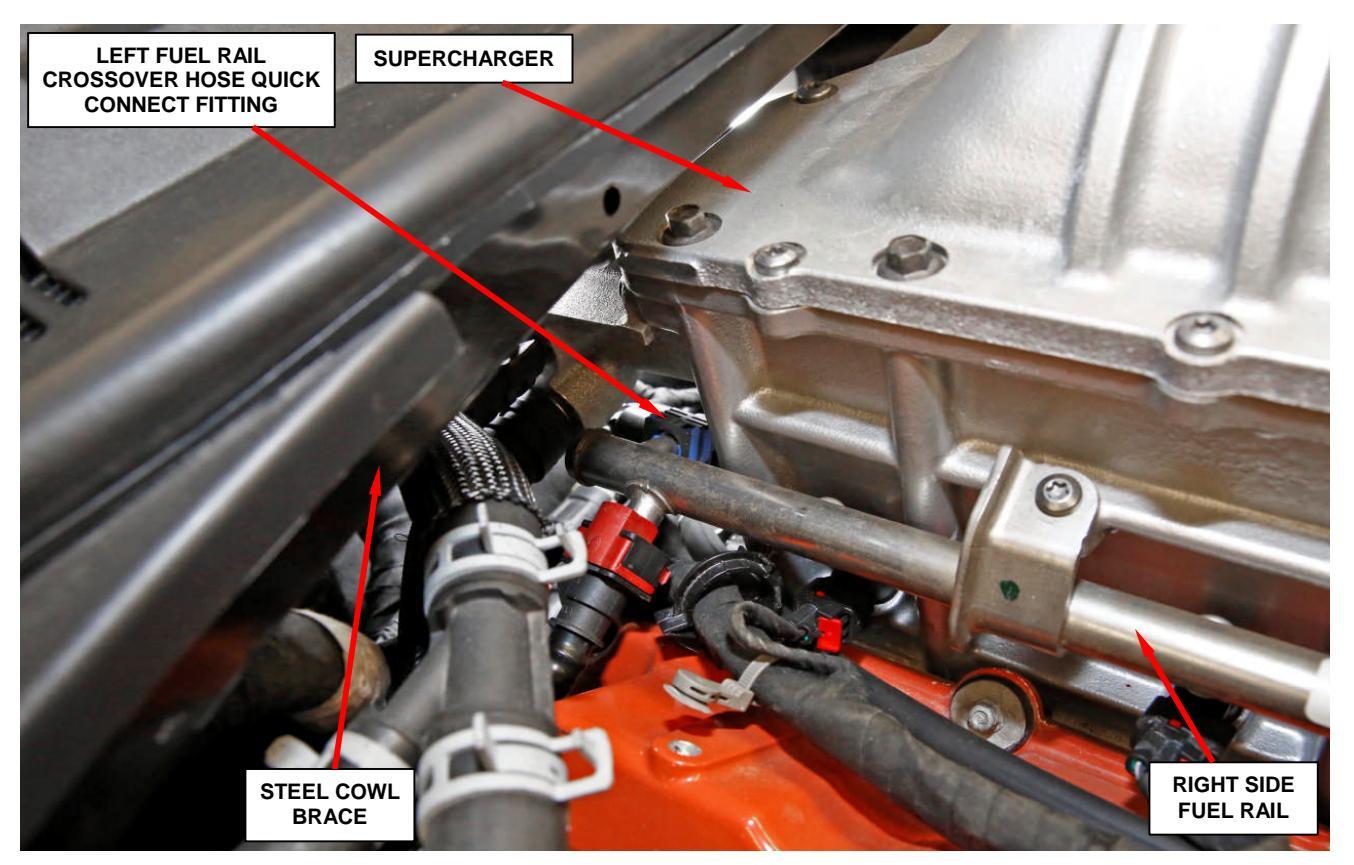
Figure 9 – Crossover Hose Quick Connect Fitting Location (LA Vehicle Shown)

NOTE: To access the fuel pressure sensor wire harness connector, reach behind the supercharger from the left side of the vehicle.

NOTE: To access the left fuel rail crossover hose quick connect, reach behind the supercharger from the left side of the vehicle.

6. Disconnect the fuel pressure sensor wire harness connector located next to the left fuel rail crossover hose quick connect fitting (Figure 9).

7. Disconnect the left fuel rail crossover hose quick connect fitting from right fuel rail (Figure 9).

- 17. Install the left fuel rail retaining bolts and tighten to 89 in. lbs. (10 N·m) (Figure 10).
- 18. Connect the left side fuel injector wire harness connectors to each fuel injector (Figure 10).
- 19. Connect the left fuel rail cross-over to the right fuel rail (Figure 9).
- 20. **For LD vehicles only**, use the following procedure to install the cowl panel and cross-car beam:

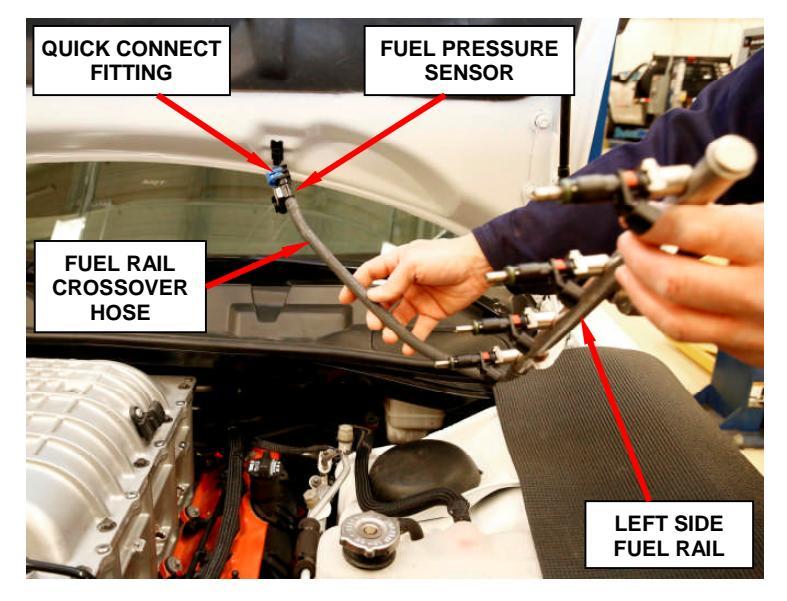
Figure 12 – Left Fuel Rail and Crossover Hose

CAUTION: Note the routing of the crossover hose before removing the fuel rail and crossover hose assembly.

11. Remove the left fuel rail, with fuel injectors attached, from the engine (Figure 12).

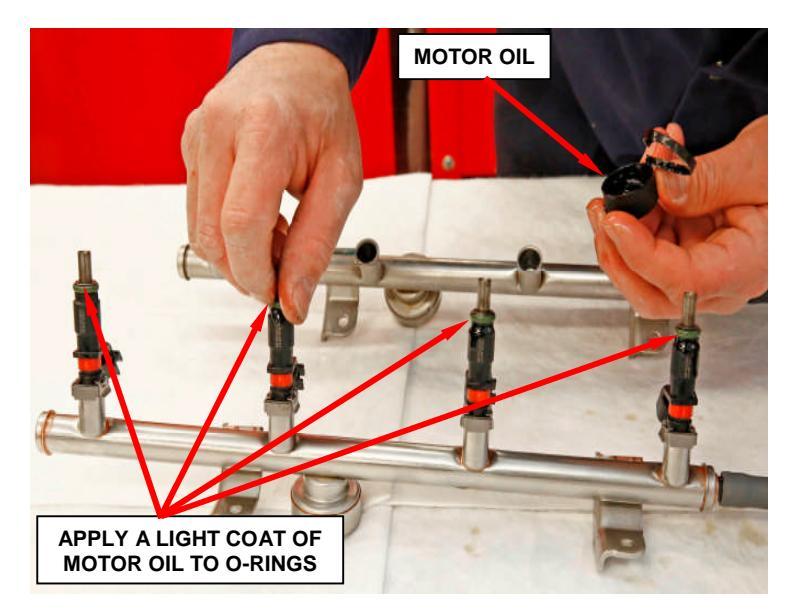
Figure 14 – Apply a light Coat of Motor Oil onto Green Fuel Injector O-Rings

CAUTION: Use care not to damage the fuel injector O-ring.

- 13. Apply a light coat of engine oil to the green fuel injector O-rings (Figure 14).
- 14. Loosely place the new fuel injector rail into position on the engine.
- 15. Position the fuel injector nozzles into the machined bores of the supercharger and correctly route the fuel rail crossover hose between the supercharger and coolant hoses.
- 16. Push the fuel rail down until the fuel injectors have bottomed on intake manifold shoulders.
